Subject: RE: EMERGENCY-#3400 MAJOR FLOODING

The water damage found is as follows; pictures attached:

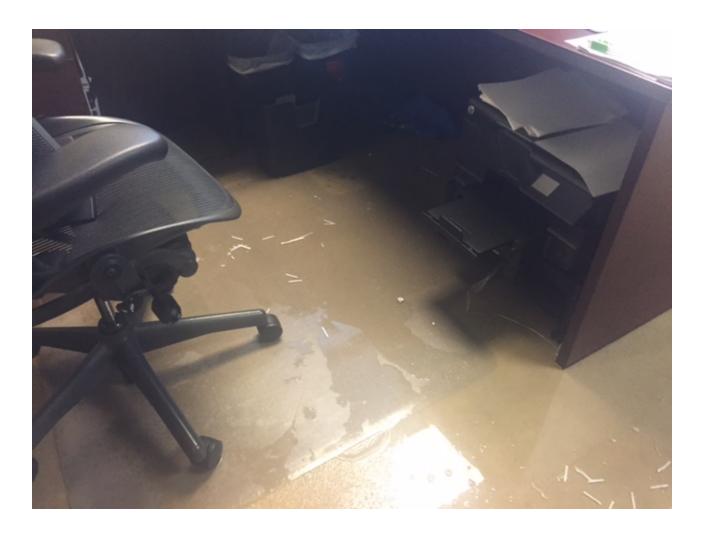
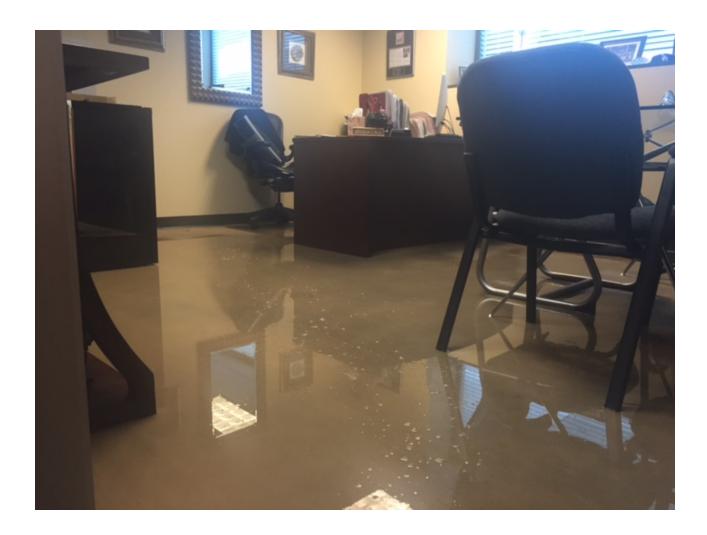
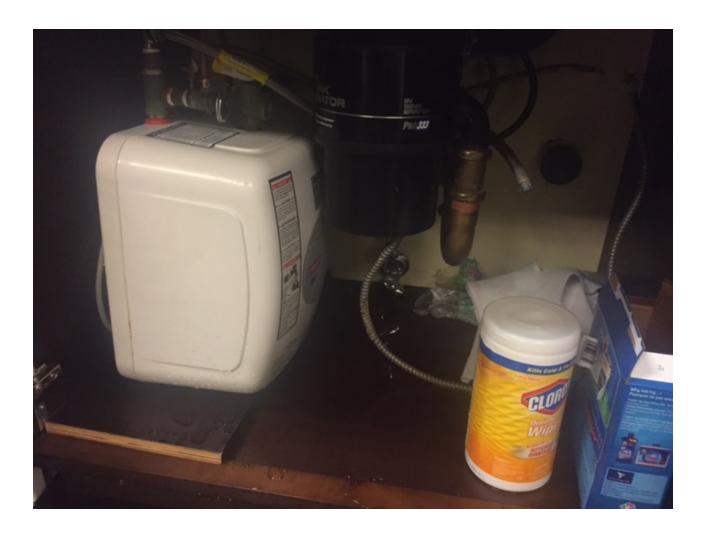
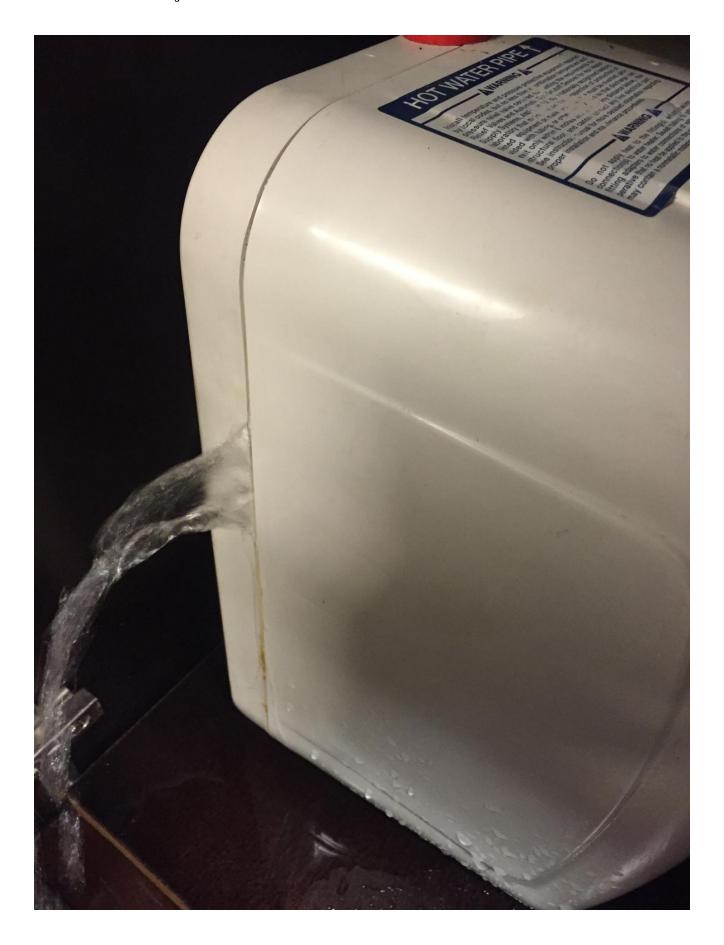
- * Standing water found under the kitchen sink cabinetry where instahot was installed. When I came into the office this morning at roughly 7:50A, the instahot was spewing water out of a side seam of the unit.

- * The hardwood flooring along the east side of kitchen is starting to warp due to water intrusion beneath the flooring.
- * Flooding went thru the kitchen/conference room drywall and into the suite hallway

* Flooding went thru the east hallway drywall into 3 offices.
- * Flooding went thru Jessica's office drywall into Josh's office, and again thru Josh's office into Katie's office.

- * There was roughly 1/4" standing water found this morning in Jessica's office, the front half of Josh's office and the northwest corner of Katie's office.

- 2. Please advise as to how the kitchen hardware, hardwood floors, wood and black rubber base, and carpet will be checked for damage. We are concerned that due to this flooding occurring throughout the night that when the suite is dried, water damage will be visible in the drywall/base. It has already been mentioned above that the hardwood flooring is starting to show signs of being warped.

- 1. While the crew dryvaccumed the immediate water present in the hallway and 3 offices, all of the furniture impacted by the water should be moved in order for 1) the pieces to dry thoroughly as well as 2) to allow all carpet to thoroughly dry. Please advise where the larger furniture will be relocated to.

- 3. If the overnight water damage is too severe to simply dry out, we will request new product be installed. This would include drywall, hardwood floors, cabinetry, carpet, wood and black rubber base.

As for the instahot that was installed yesterday and found spewing water this morning, we will want that completely removed and will want a new one installed. With regards to the type of new product to be installed, please confirm that it is the correct grade to handle the plumbing connection to both the sink and the dishwasher. During the install yesterday, it was connected to both of these.
